Inspection Report

Chief's Order No. 2014-541

Division of Oil and Gas Resources Management (DOGRM)

Inspection Date: 05-08-2018

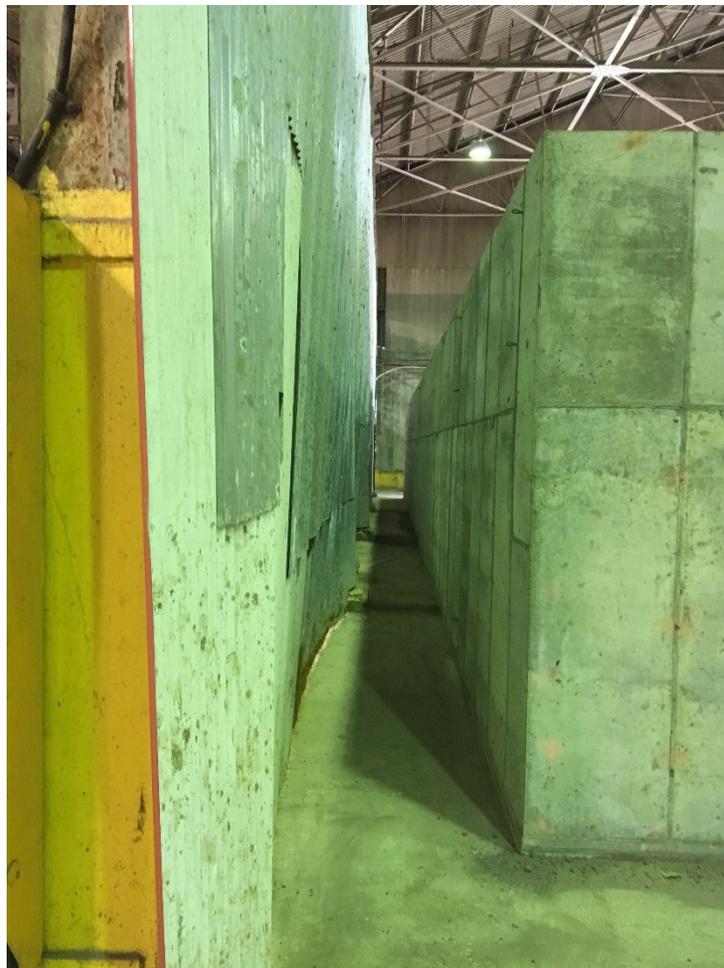
- The facility has implemented and improved housekeeping protocols. They have added two staff members to maintain the cleanliness of the floor. The machinery is on a cleaning rotation to minimize issues. There were employees actively sweeping up debris and dust during the inspection. No free liquids were observed on the floor. Jerrit Knapp surveyed DOGRM staff's boots prior to leaving the warehouse area.
- Mike stated Austin Masters has hired a safety consultant to help them formulate safer work conditions and techniques.

Improved housekeeping behind concrete bins

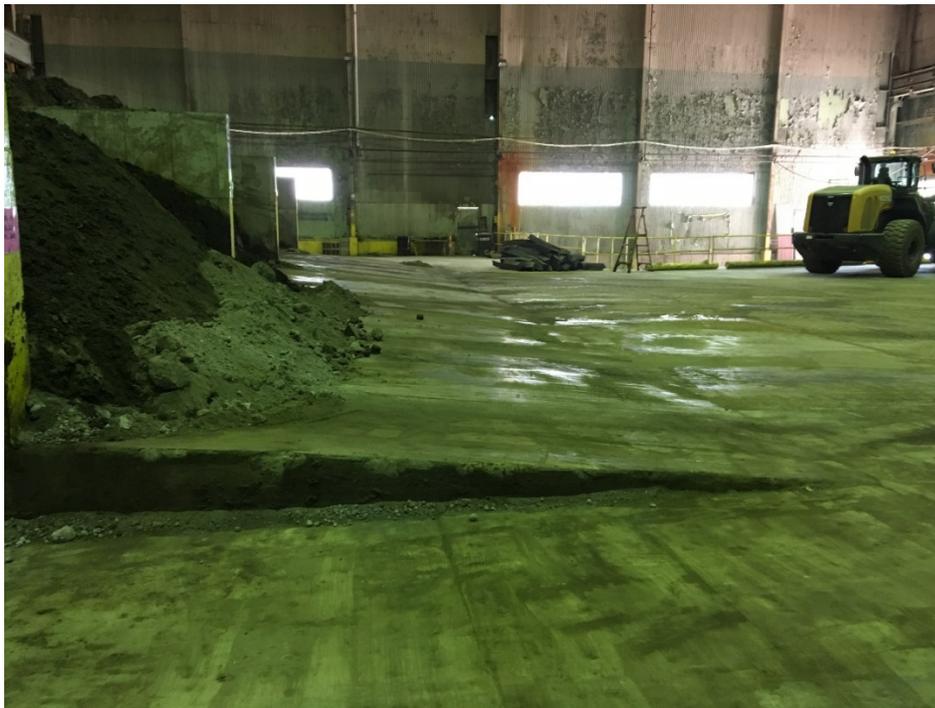
- There were no large piles of waste located on the floor. All waste was stored in the newly constructed concrete containment bins. The waste substances within the concrete bins were piled above the top of the containment walls and beyond the containment crest of the sloped floor. The large volume of wastes was reportedly due to a switch out of train cars.

Excess waste not within containment.

- Reduce excess waste volumes in the concrete containment bins.
- Repair and/or replace the roof. Stormwater ponding and running across the floor increases the opportunity for the waste to be tracked from the warehouse and is a hazard for the workers.
- Complete and submit modification changes and updates per clarification discussion.
- Install temporary curbing and secondary containment under the filter presses until a final solution can be engineered and constructed.

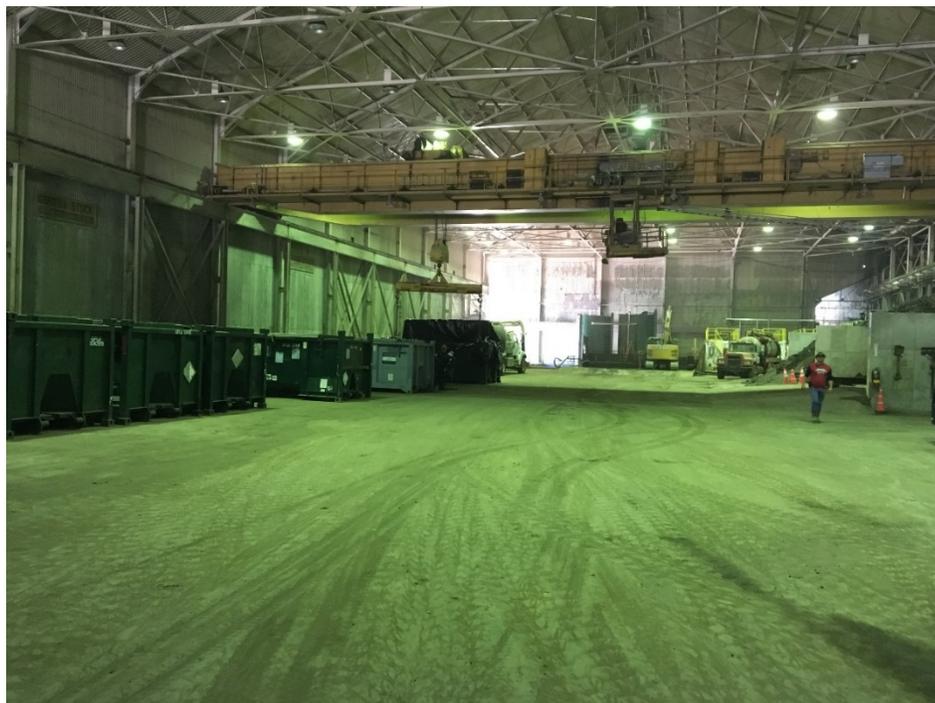
- New containment boxes were in use at the facility to store and transport the waste for disposal. Approximately 20 steel boxes were currently at the facility and approximately 60 are planned to be in rotation for waste transport. Austin Masters will be transporting the waste in the new steel boxes by train in lieu of the previously used open cars. This change will happen once all storage boxes become available by the supplier.

New steel boxes for disposing waste. Note that waste is not on the floor.
