Trip Report

Division of Oil and Gas Resources Management

Location: 801 N. Fourth St., Martins Ferry, Belmont County

Purpose of meeting: Facility inspection

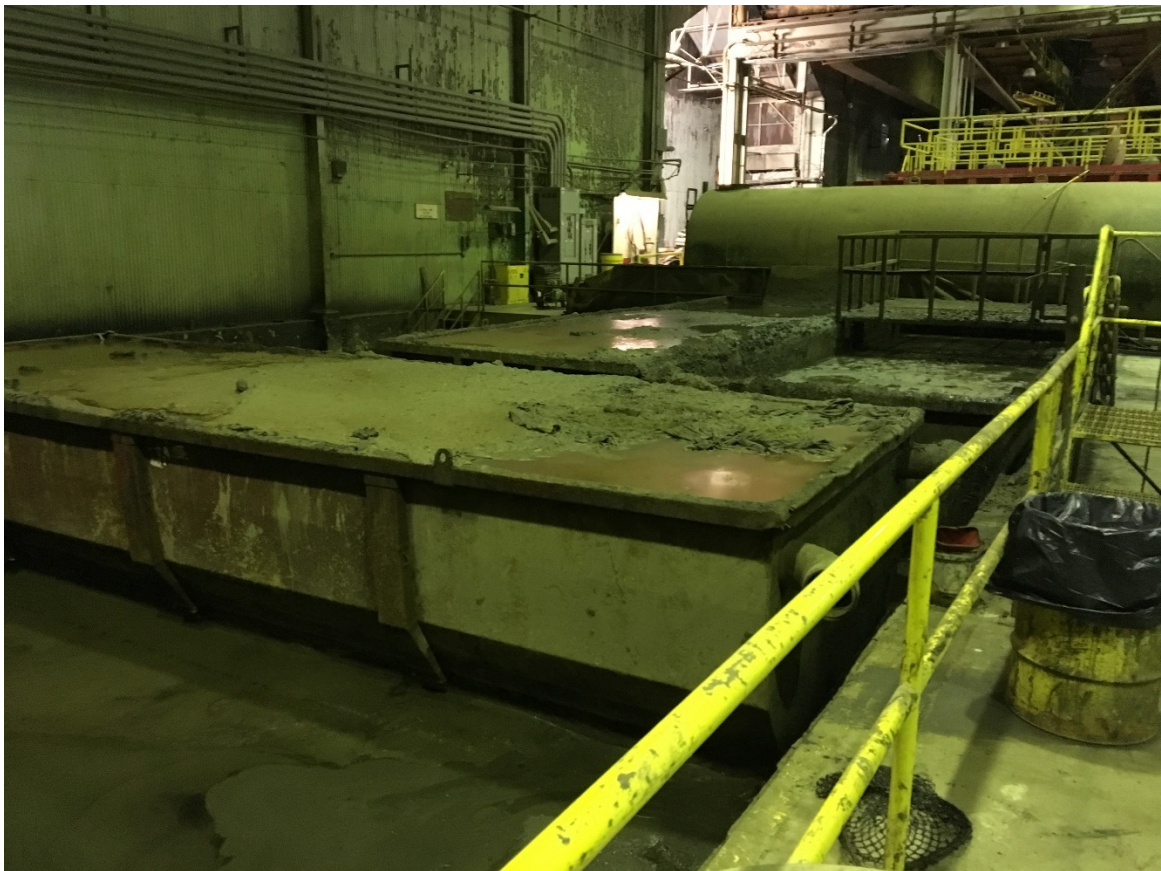
- Two 400 bbl liquid tanks were on site for storage of waste waters from the filter presses.
- As a safety measure, a platform had been constructed at the back of the solidification pits (at the back of the warehouse) for use by an attendant to watch other employees during the rinsing of trucks or containers after dumping. The halfrounds used for offloading wastes were overflowed and waste was being stored inside the secondary containment pit.

Overflowed halfrounds used to offload waste. Waste was observed inside the secondary containment pit.

- Empty and clean the secondary containment pit where half rounds used to offload wastes had been overflowed. Complete by 11/08/2017. Primary containment shall not be used as secondary containment.
- Provide primary containment and secondary containment for all oilfield wastes.
- Provide secondary containment for empty boxes that have not been cleaned.
- Update the existing application to include all primary and secondary containment volumes and details, equipment, and operations performed by the facility. Austin Masters is currently operating outside of the approved application documents, that constitute the authorization included in the Chief's Order.
- Submit secondary containment design documents to the division for approval prior to construction.
