Inspection Report

Division of Oil and Gas Resources Management (DOGRM)

Site Name: Austin Master Services Facility

Purpose: 4th Quarter Site Inspection 2020

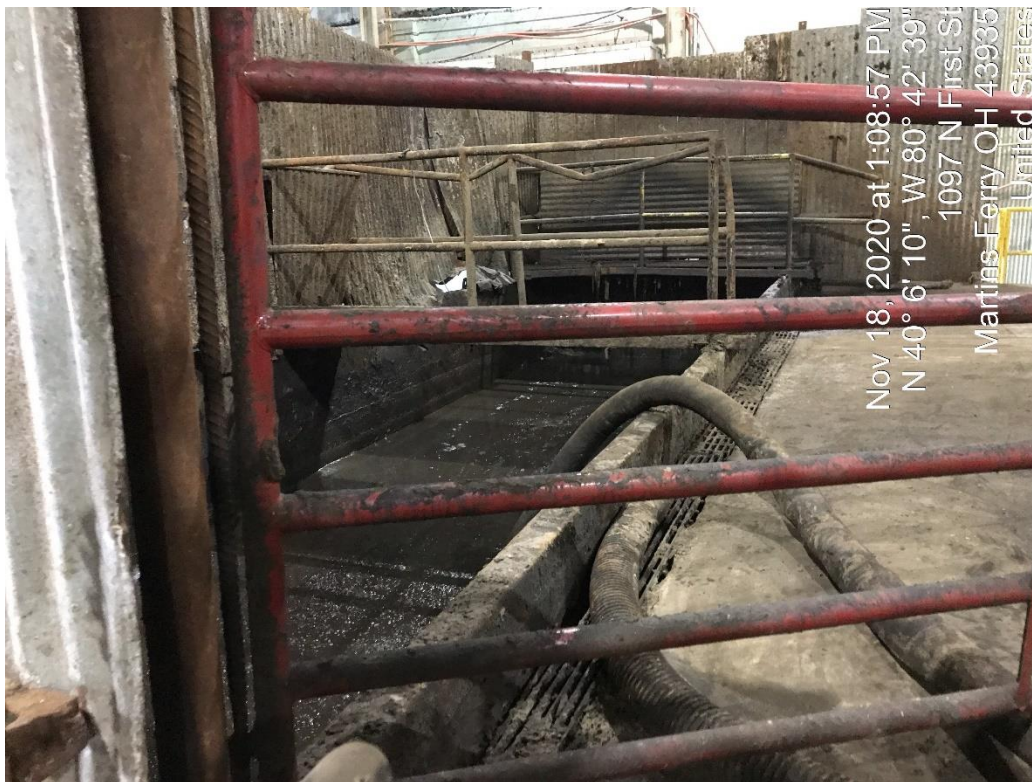
- Three 500 bbl used vertical tanks were still being stored at the entrance of the facility.
- The low level TENORM mixing pits were half full of waste.

Low level TENORM mixing pit

- Appropriately store waste within each bin's capacity or bring in additional roll offs to facilitate proper storage.
- Establish and maintain a physical delineation around the filter sock grinder.
- Provide updated site drawings reflecting the location of the new filter sock processing equipment area, plate settler, and the addition of the oil-water separator. Submit drawings in PDF format.
- Clean out sawcut drain to sump adjacent to storage bins #5, #6 and #7 as needed.
- Implement housekeeping protocols and maintain appropriate waste volumes in the concrete containment bins to allow for mixing and storing without spilling wastes onto the floor.

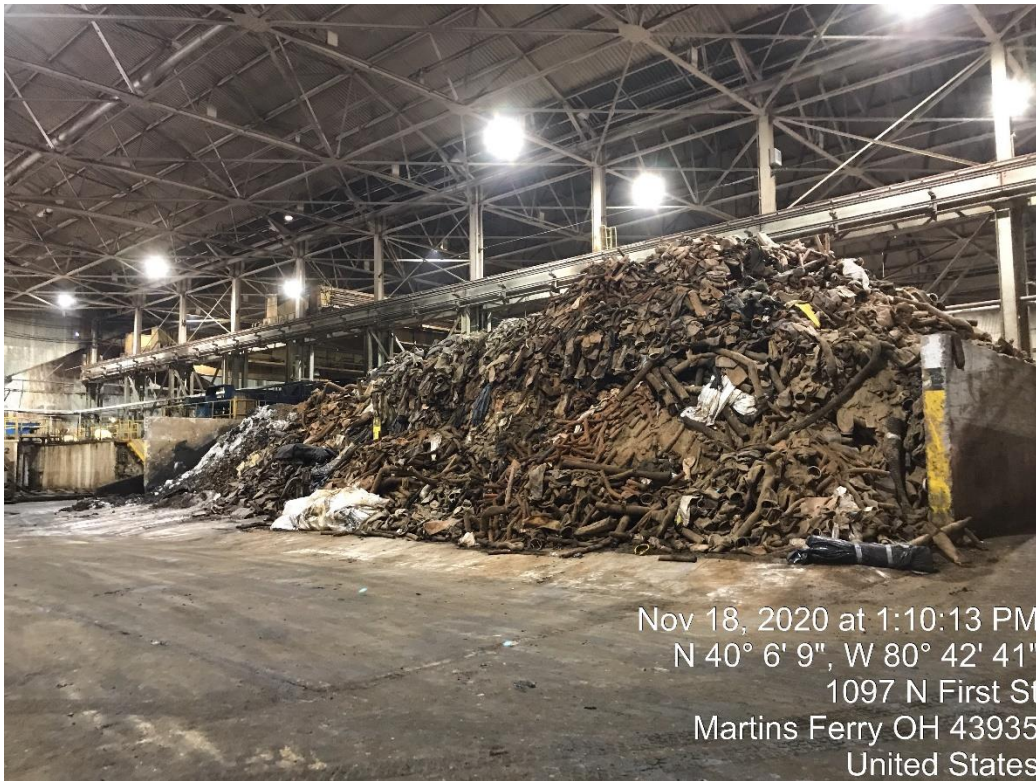
Bin #6

- Storage bin #5 was at capacity and storage bin #6 containing filter socks was beyond capacity and the waste was being stored beyond the berm and above the walls.

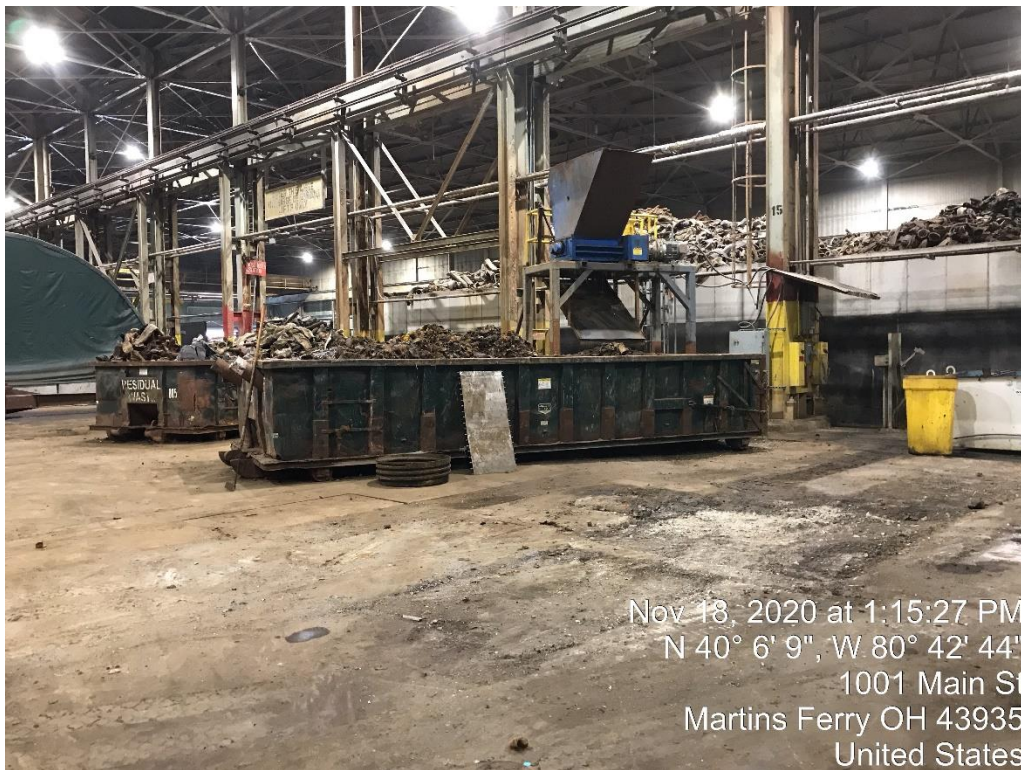
Filter sock grinder

- The grinder for processing filter socks was operational and shredded filters were being stored in a half round underneath the grinder. The grinder was repaired and back in operation on 11/16/2020. A demonstration was provided of the grinder and no dust was observed during the operation.

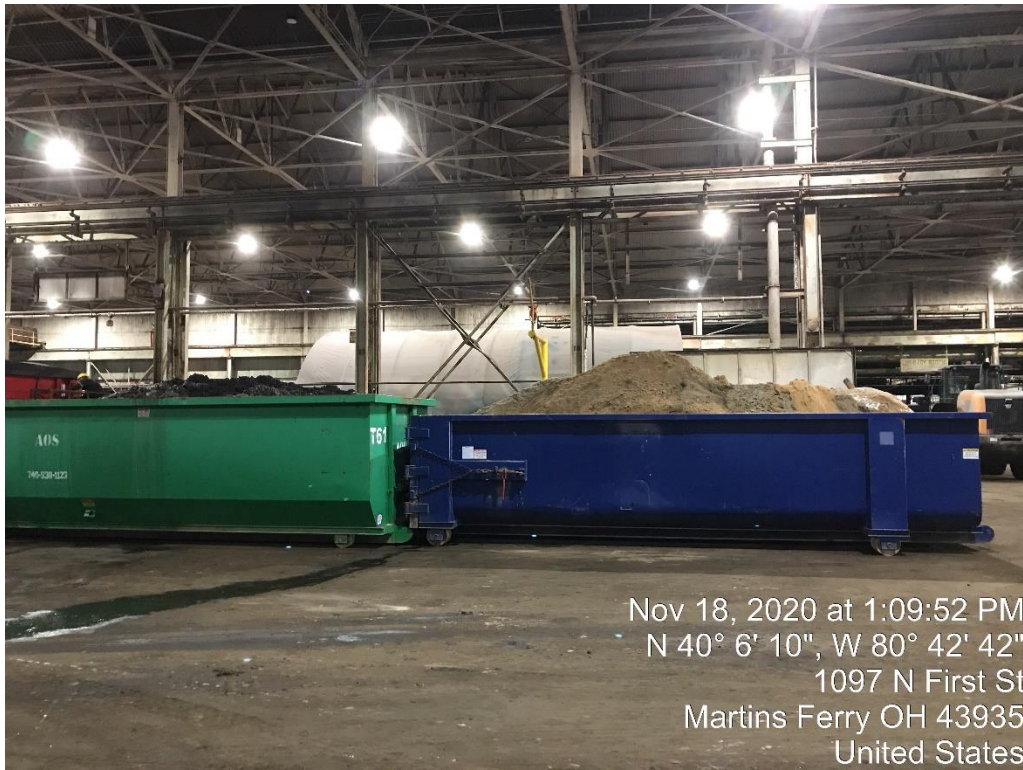
- The roof had been repaired since the last inspection.
- There was only one railcar on site and AMS is awaiting additional railcars to arrive.
- The trench drain in front of storage bins #1, #2, and #3 was being constructed during the inspection. Therefore, half rounds were being stored in various locations around the facility to store low level TENORM waste.

Half rounds storing waste
