Inspection Report

Division of Oil and Gas Resources Management (DOGRM)

Site Name: Austin Master Services Facility

Purpose: 1st Quarter Site Inspection 2020

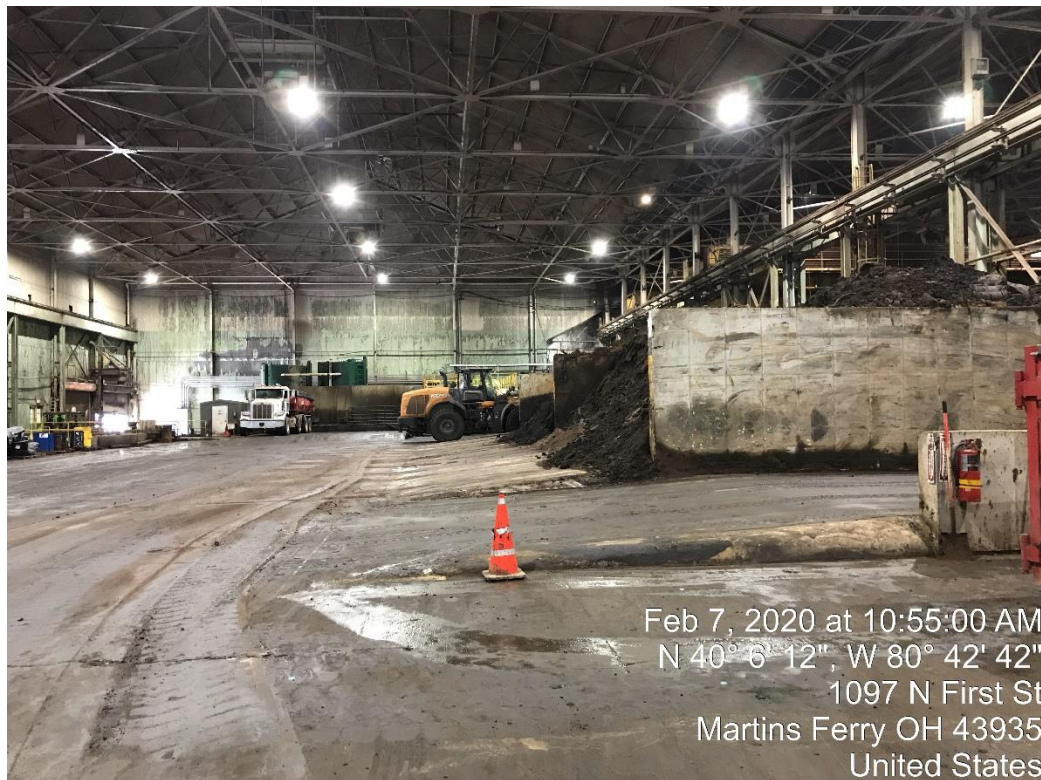
Bins #5 and #6

- Storage bins (#5 and #6) for high level TENORM waste were beyond capacity and the waste was being stored beyond the berm and above the walls. Bins #1 and #3 for the low level TENORM waste were at capacity. No liquids were noted on the floor in front of the storage bins.

- Per the 11/20/2019 inspection report requiring disposal of waste by 1/15/2020, waste facility staff witnessed that waste had been removed at the 1/7/2020 Radiation Safety Inspection. Appropriately store waste within each bin's capacity or continue to bring in additional roll offs to facilitate proper storage.

- Clean out sawcut drain to sump adjacent to storage bins #5, #6 and #7 as needed.
- Continue to implement housekeeping protocols and to maintain appropriate waste volumes in the concrete containment bins to allow for mixing and storing without spilling wastes onto the floor.

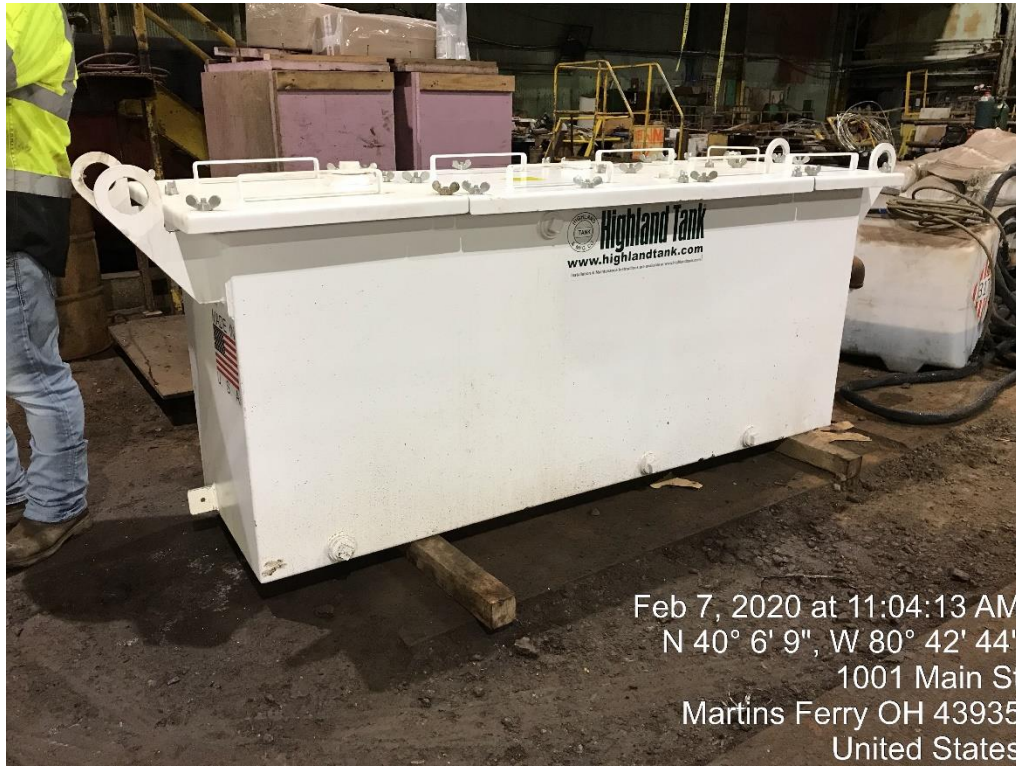
Oil-water separator

- AMS intends to install an oil-water separator for further processing of the liquid waste.
- They also intend on installing a control room for mixing tanks and the filter press on stilts over pump area.

- Provide updated site drawings reflecting the new low level TENORM mixing pits, the modifications made during construction and the location of the new filter sock processing equipment area, and the addition of the oil-water separator.

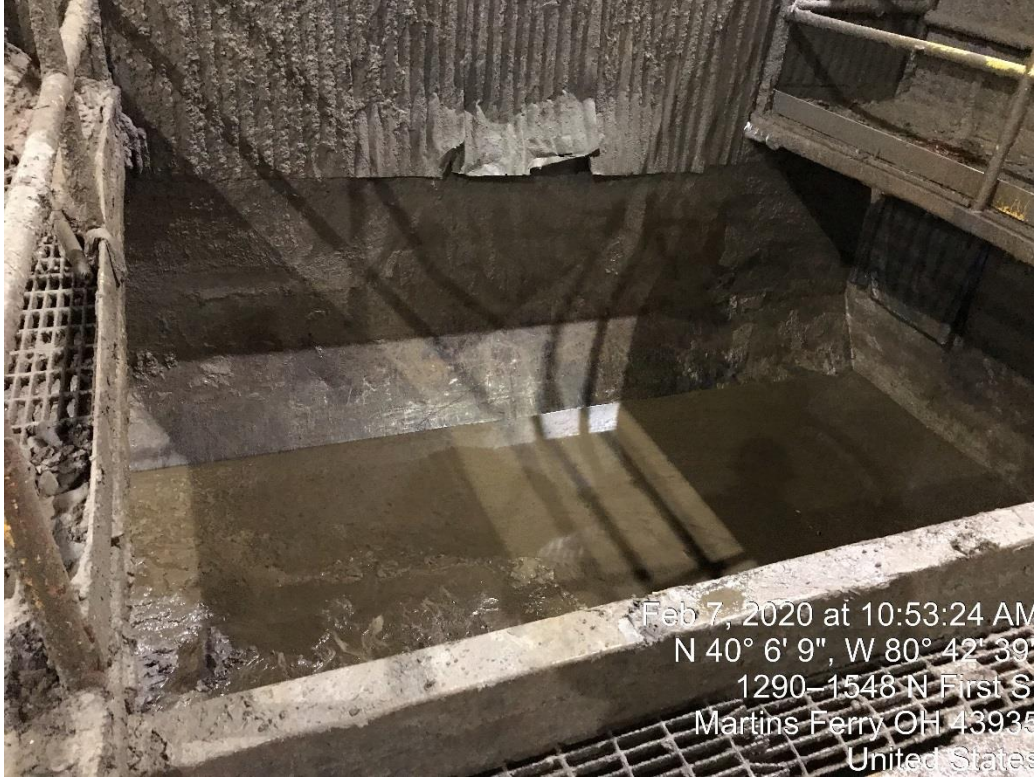
Low level TENORM mixing pit

- The low level TENORM mixing pits had minimal waste. Multiple lined roll offs were noted around the facility for waste storage until railcars arrive.
- The grinder for processing filter socks was nonoperational and waiting for repair parts.
