Trip Report

Division of Oil and Gas Resources Management

Chief's Order No. 2014-541

Purpose of meeting: Facility inspection

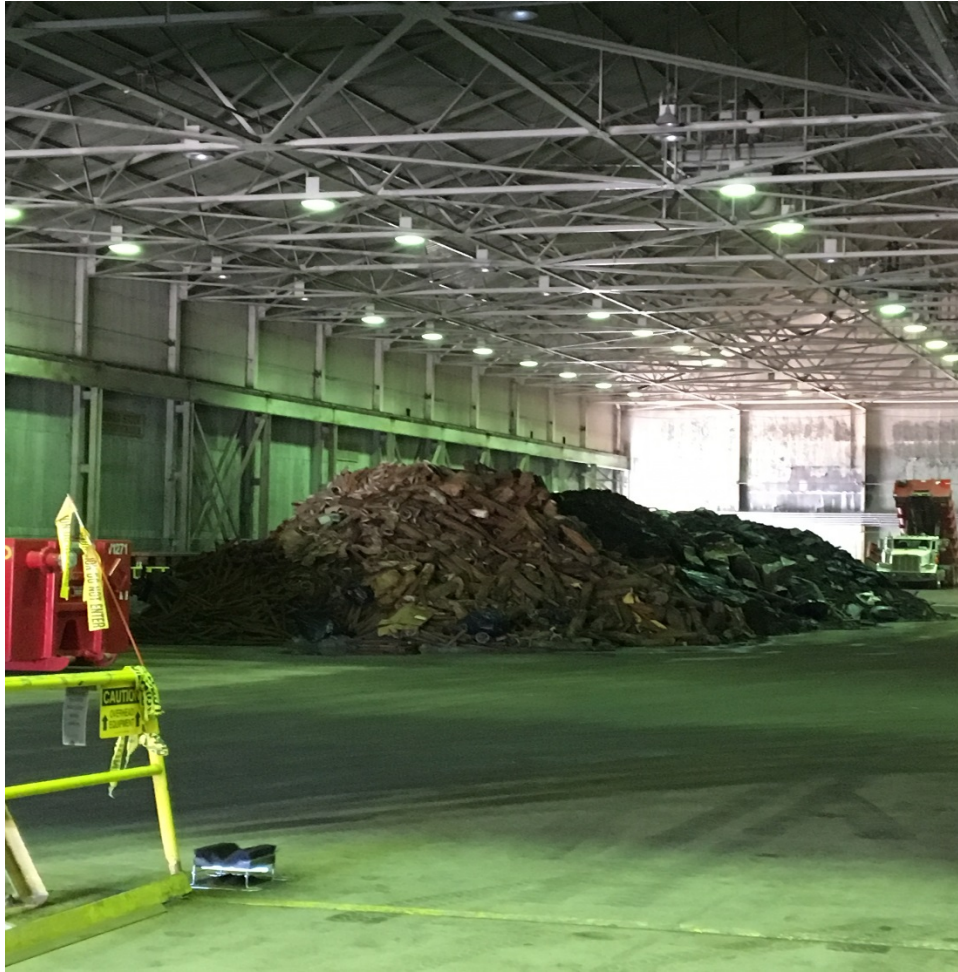
- Filter socks are being stored on the warehouse floor in one large pile. There was no apparent designated area for the storage of filter socks.
- The floors appeared to be dirty with oilfield wastes. When asked about the cleanliness of the warehouse, Troy stated the warehouse roof leaks water during rain events, making it difficult to keep the warehouse floors clean.

Pile of filter socks stored on warehouse floor.

- Continue or implement procedures to improve the “cleanliness” of the warehouse floor. Regular hosing of the floor should be performed to ensure waste substances are maintained in the pits and not tracked by equipment.
