Inspection Report

Chief's Order No. 2014-541

Division of Oil and Gas Resources Management (DOGRM)

Site Name: Austin Master Services Facility

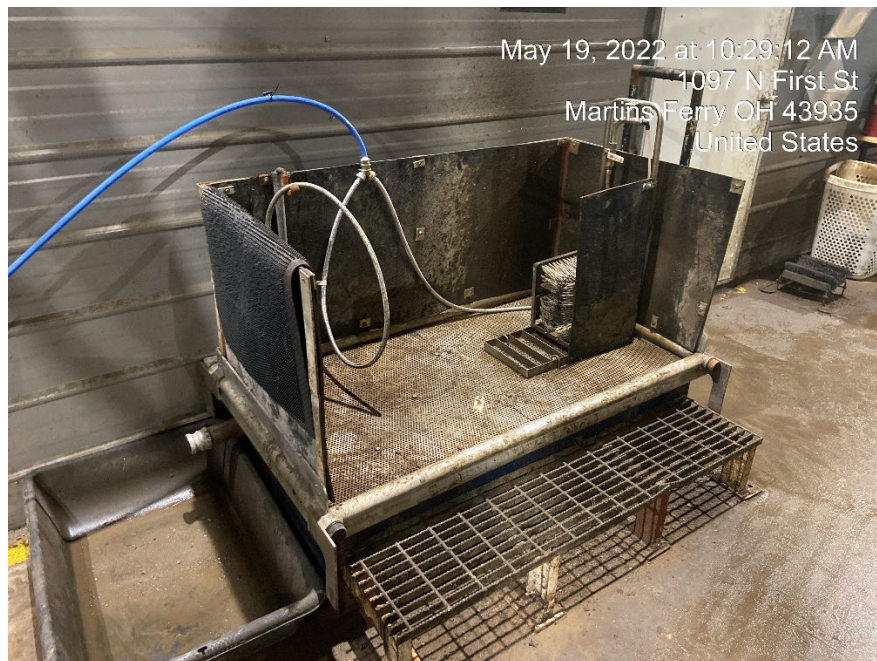
- The floor of the facility was free of waste.
- Filter press area was clean underneath.
- A new boot washing station was installed for use by employees and visitors upon exiting the facility. DOGRM staff was frisked upon exit.

Boot Washing Station

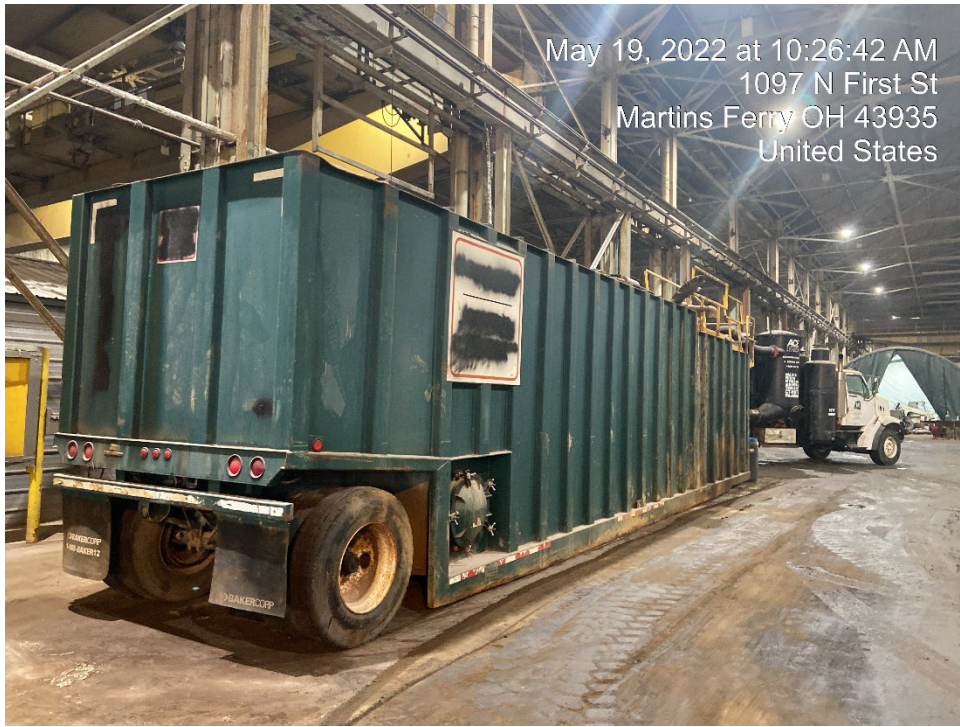
- The green 500 bbl frac tank had been relocated to the north end of the building near bins 1 – 3. The intent is to fabricate the tank into an agitator.

Relocated green 500 bbl frac tank

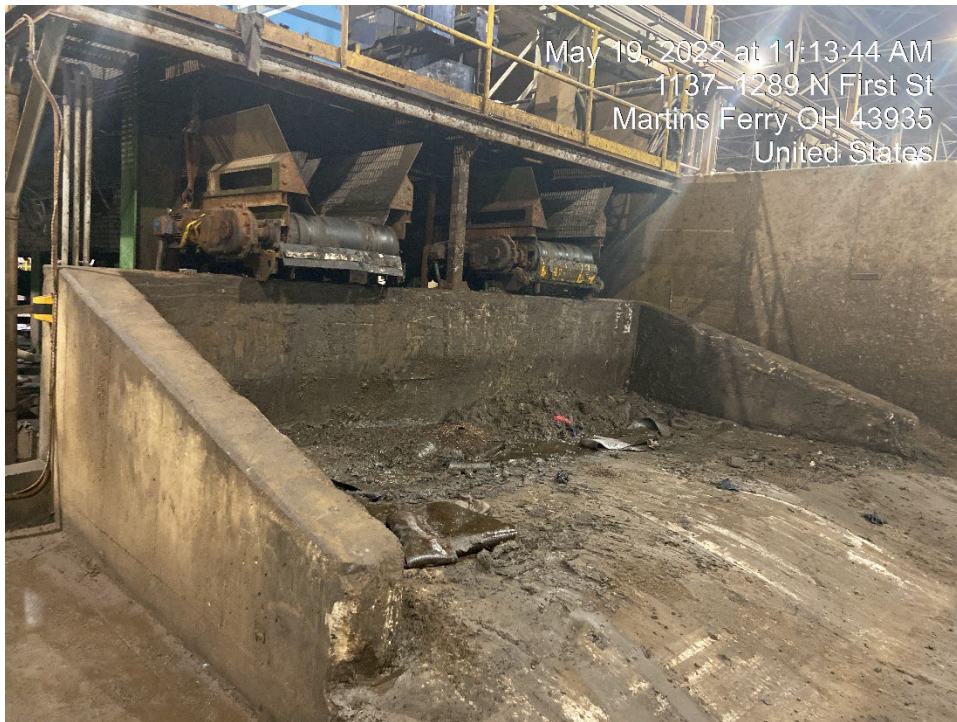
Filter Press Solids Processing Bin

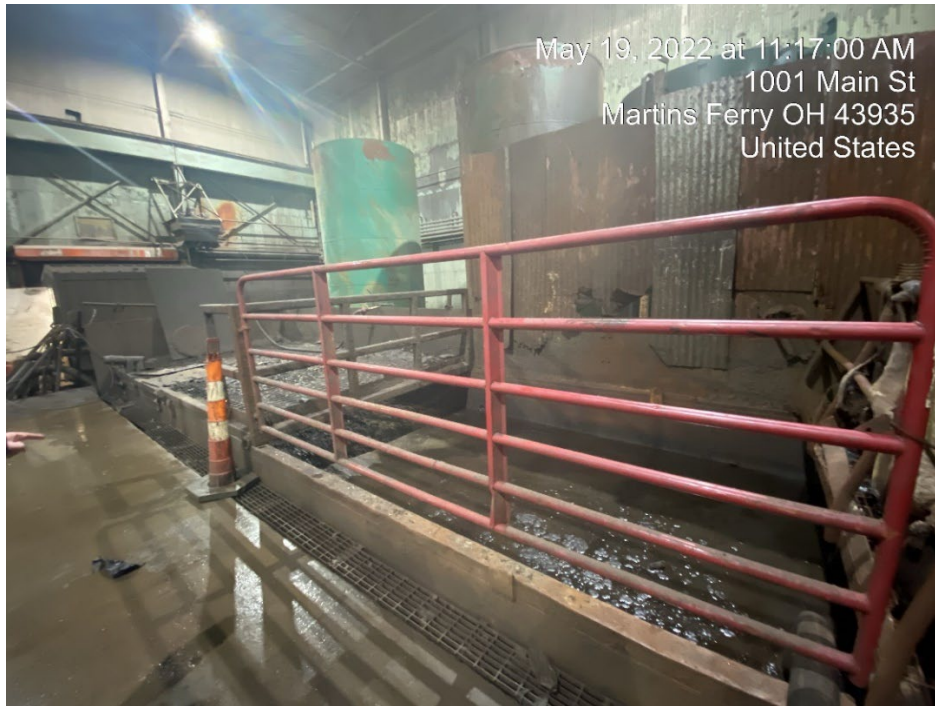
Truck wash area and mixing pit

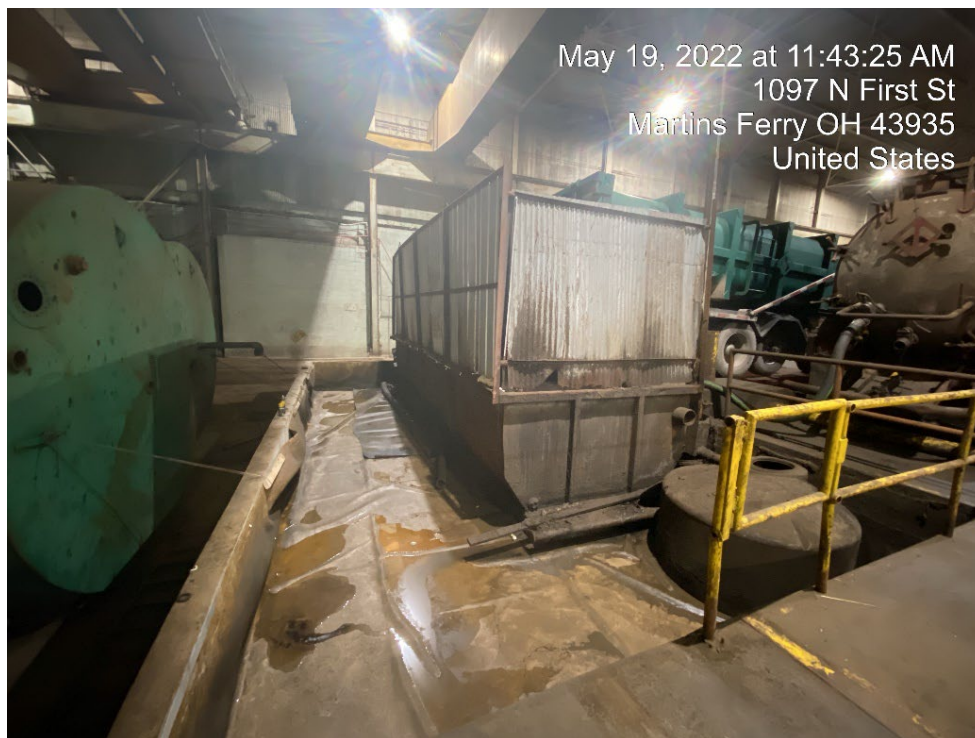
- Storage bin #5 was at 25 percent capacity, storage bin #6 was at 70 percent capacity and storage bin #7 was at 20 percent capacity.
- Cold mixing pit splash panels were in good condition.

Cold Mixing Pit Sideview
